Cost and Performance Report

(RC-200610)

Application of a Solvent Emulsion Technology for PCB Removal from Older Structures on DoD Facilities

November 2011

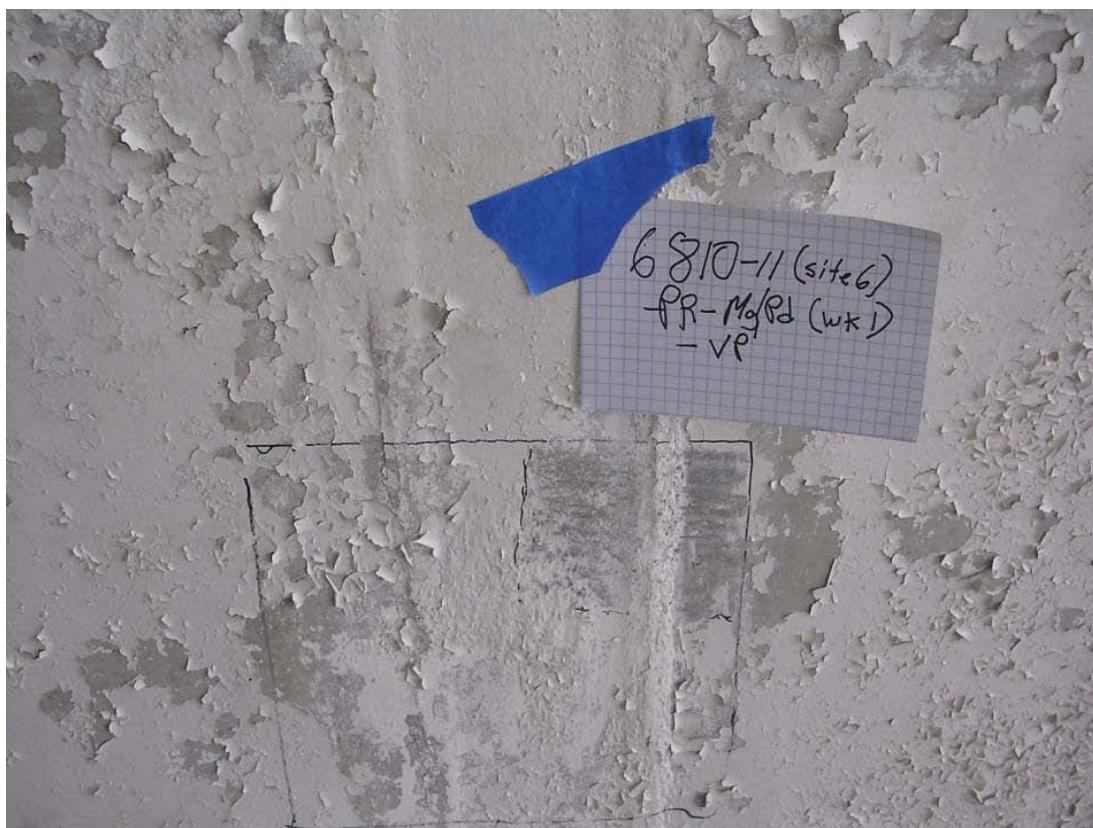
Figure 8. Representative quality of the paint in concrete bunker 6810-11.

test surfaces. Initial visual inspection of the painted surfaces at the four different test sites, two concrete press bunkers, the nitrating house, and the staging area indicated that the paint was in poor condition prior to treatment with BTS. Significant peeling and flaking of the paint was evident at each of the test sites. Figure 8 gives a representative view of the quality of the paint in the concrete bunkers.

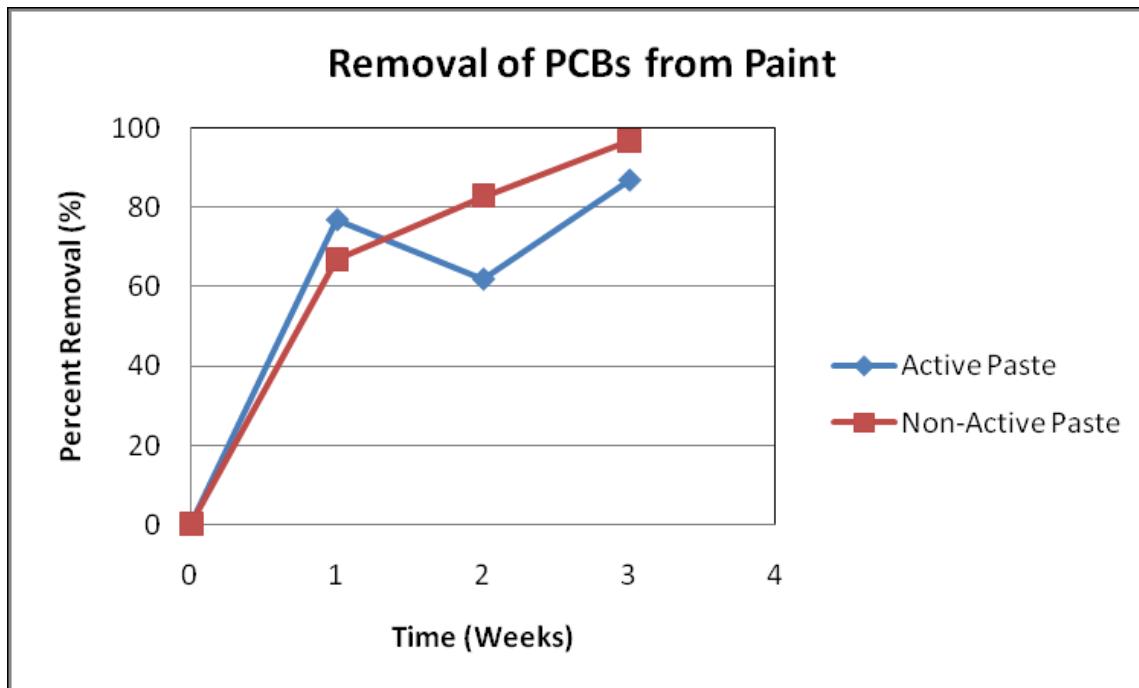
Figure 9. PCB in paint concentrations after 1, 2 and 3 weeks of exposure to BTS.
Average of samples (two samples at Week 1 and Week 2 and 10 to 20 samples at Week 3).

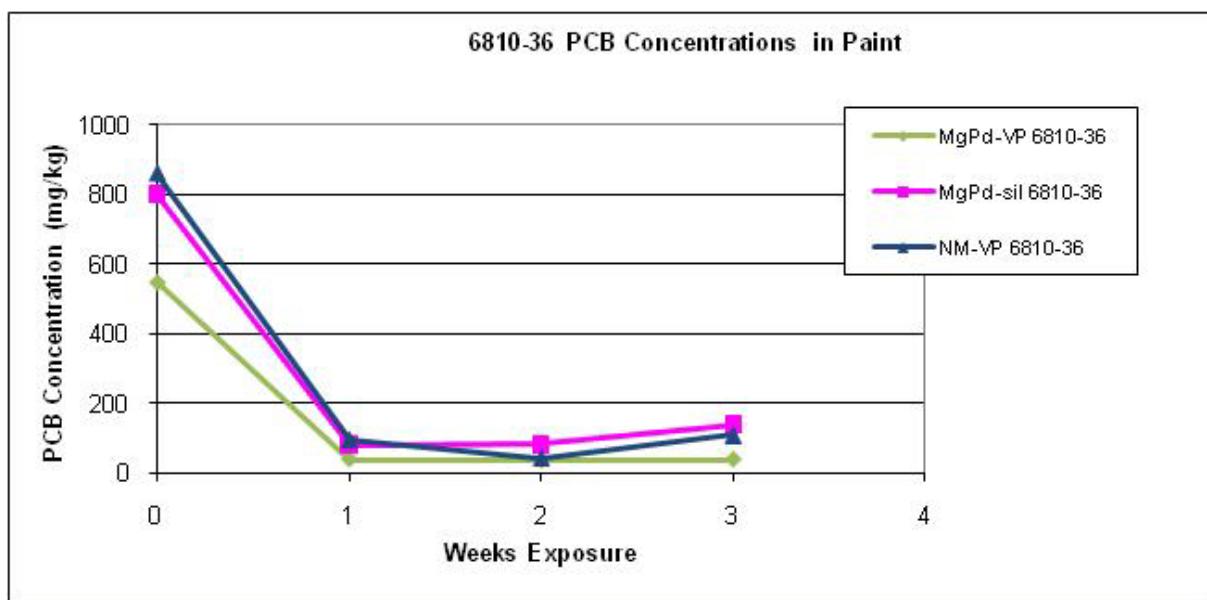
Figure 11. Average PCB concentrations in paint samples from 6810-36.

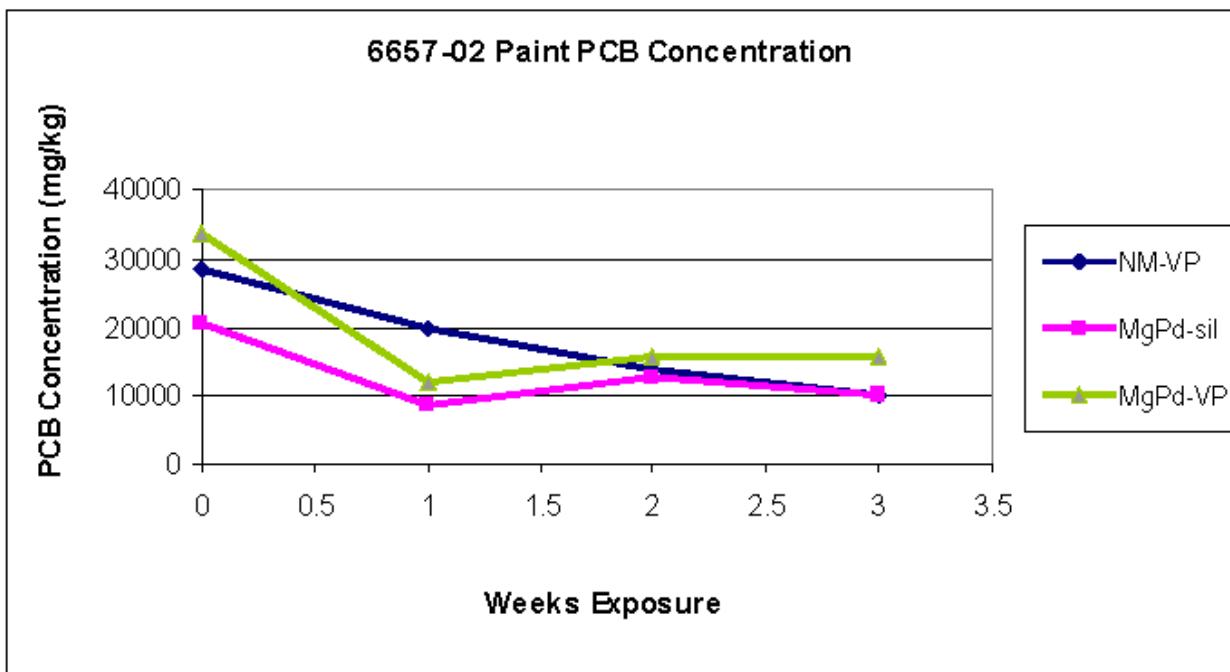
The PCB concentrations in the paint located at the different treatment sites at Badger at times of pre-demonstration, and after 1, 2, and 3 weeks of treatment are shown in Figures 10, 11, 12, and 13. As can be seen from the data, the major drop in PCB concentration occurs in the first week. The concentrations of PCBs in the paint do not change significantly between Week 1 and Week 3.

Figure 12. Average PCB concentrations in paint samples from 657-02.

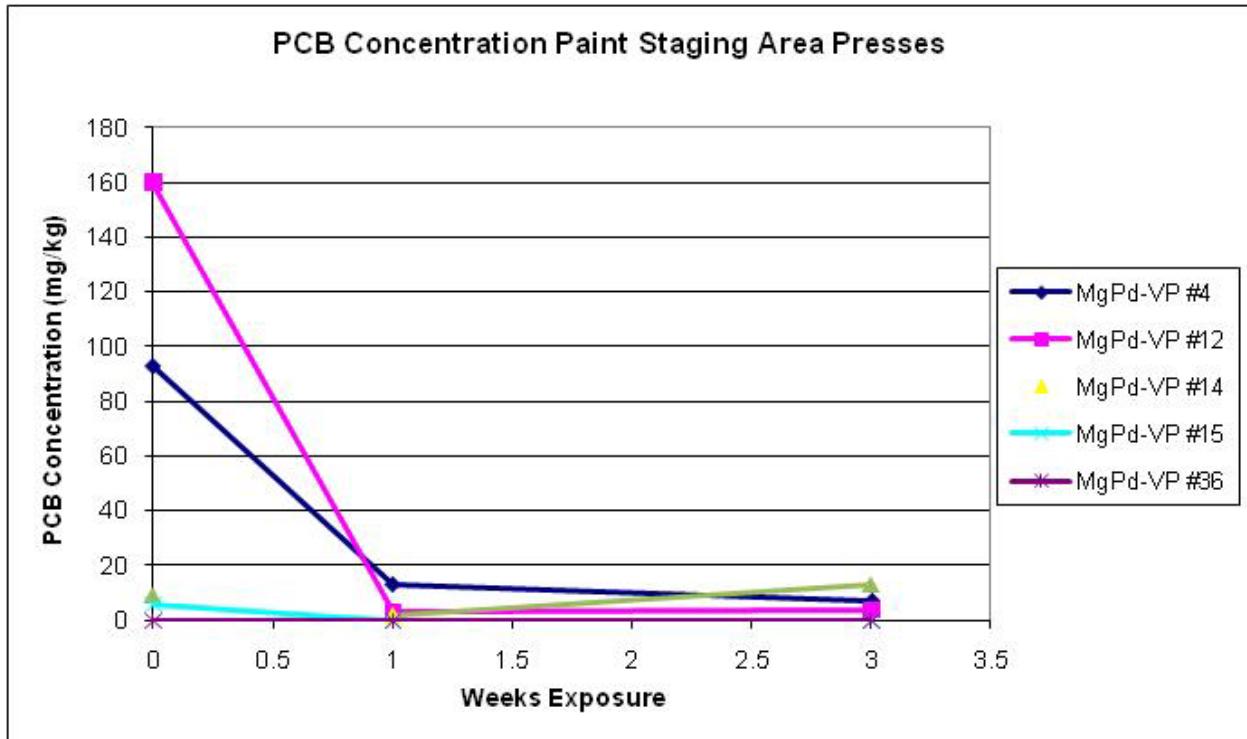
Figure 13. Average PCB concentrations in paint samples from various staging area equipment at Weeks 0, 1, and 3 after BTS exposure.

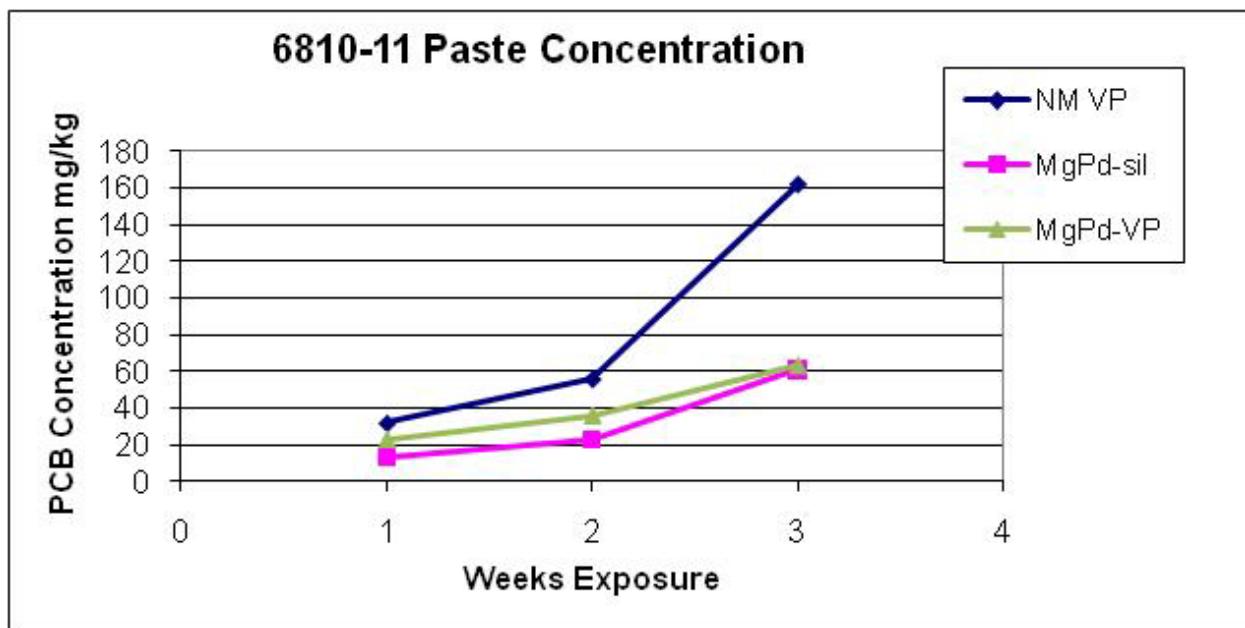
The BTS paste was also analyzed for PCB concentrations after application and removal. Samples of BTS paste were collected from each test location at the same time after treatment that paint samples were collected. The data from these analyses is plotted in Figures 14, 15, 16, and 17.

Figure 14. Average PCB concentration in paste for Weeks 1-3.

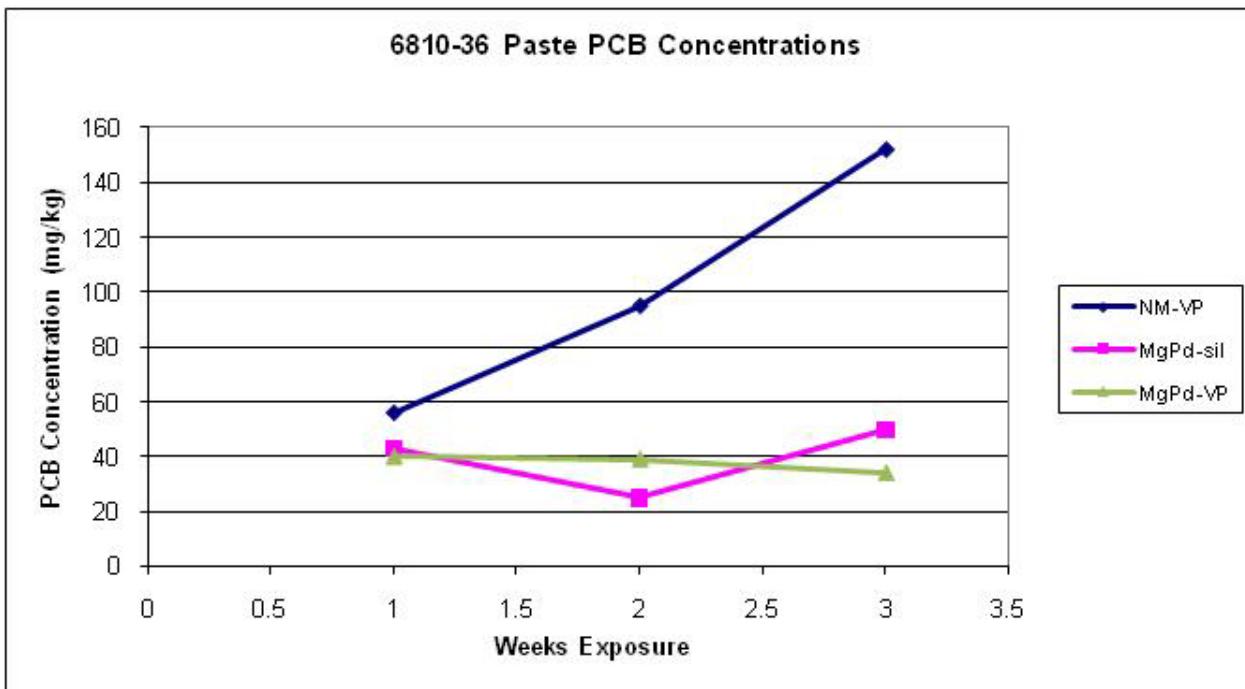
Figure 15. Average PCB concentrations in paste sampled at Weeks 1-3 after BTS application.

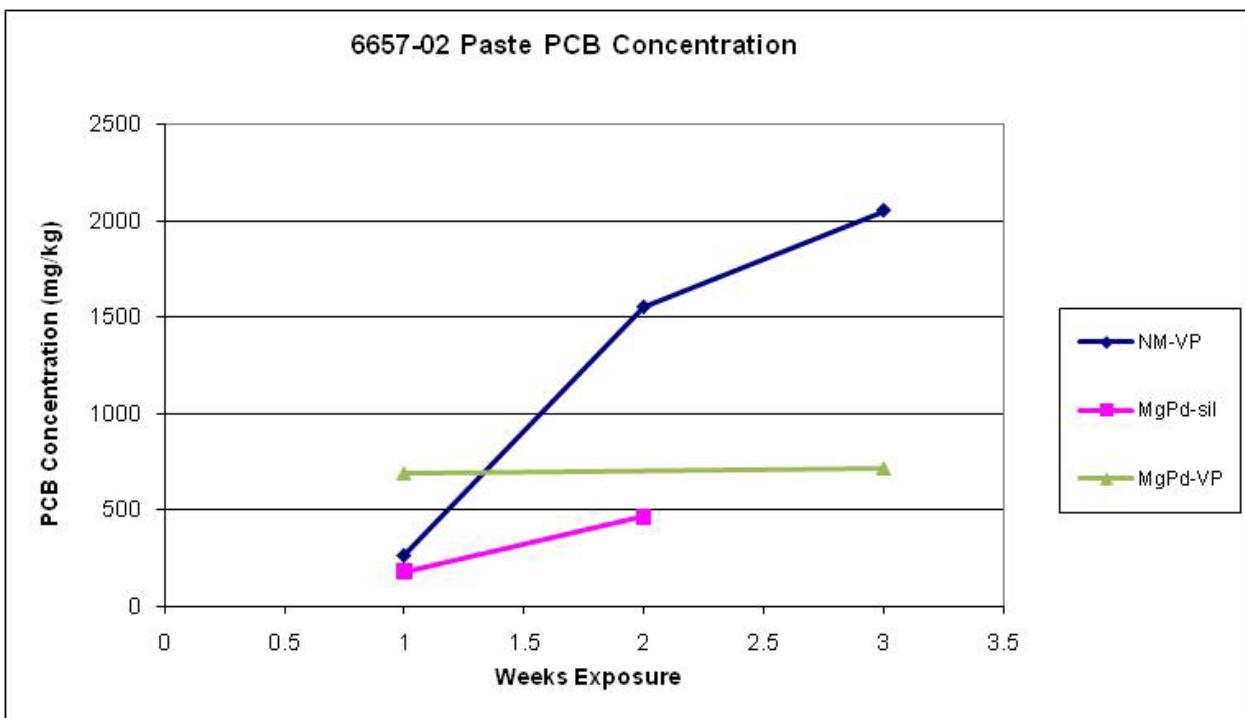
Figure 16. Average PCB concentration in pastes from building 6657-02 for Weeks 1-3.

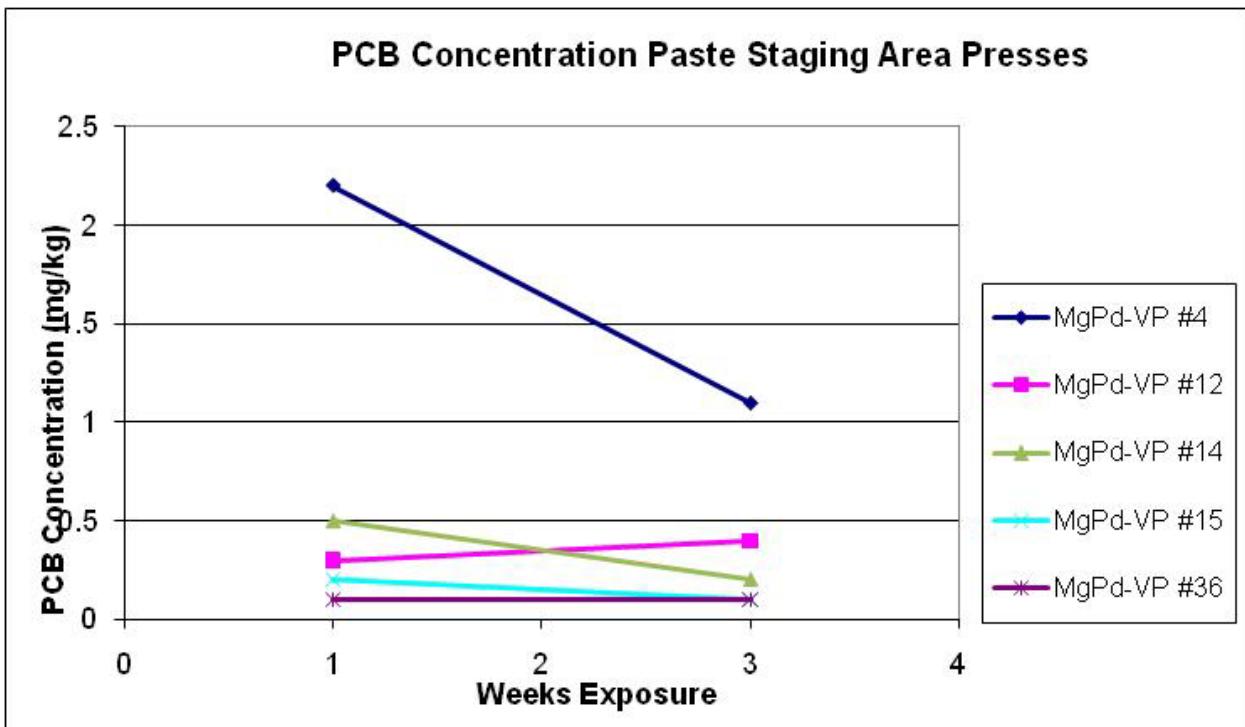
Figure 17. PCB concentration in paste from staging area (all presses) for Weeks 1 and 3.

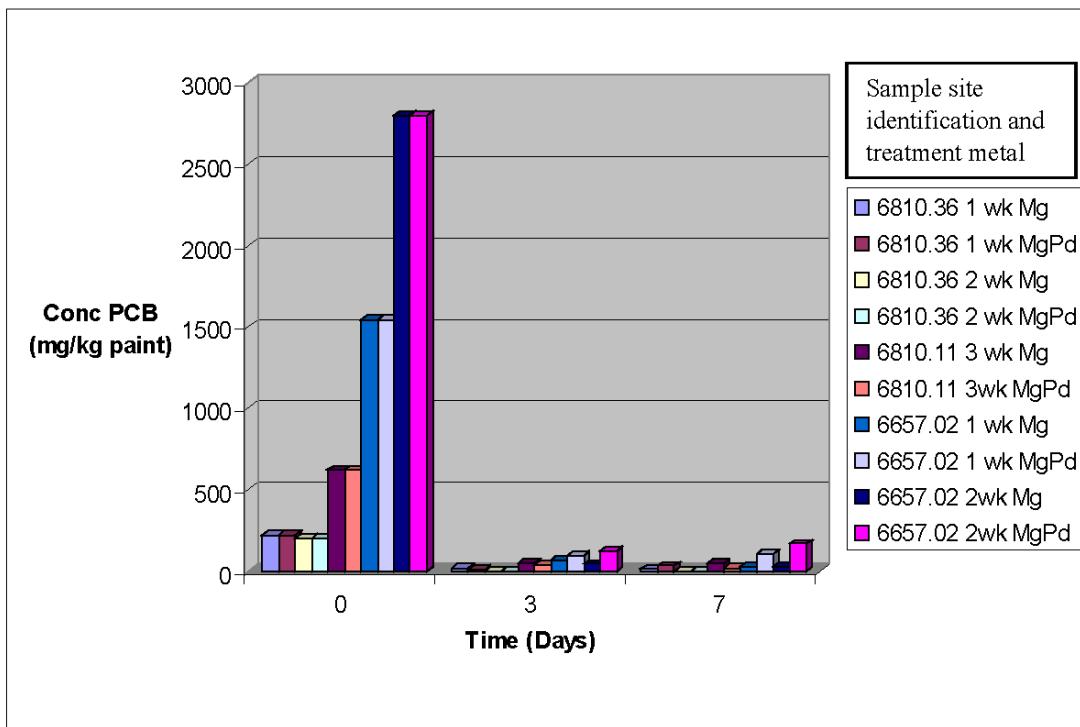
Significant PCB degradation was observed in the paste even after only 3 days of treatment. Evidence of this can be seen in the NM- 6657-02 2-week sample, where the PCB levels dropped from an initial value of 2797 mg/kg to 46 mg/kg after only 3 days of treatment with Mg. The other piece of information that is of significant importance is that the Mg particles performed as well as or better than the Mg/Pd particles. This is extremely important because the removal of the Pd from the BTS system reduces the cost of the treatment metal particles by more than 50%. In addition, it eliminates potential concerns related to the release of Pd into the environment.

Figure 18. Results of PCB degradation by Mg and Mg/Pd particles added to the NM badger paste samples.
